Sure-Flo Screen Tests

The Model

The Sure-Flo SCS8 screen (figure 1) was tested in a WRRL facility designed to test fish screens. The facility consists of a 5.5-ft-wide by 5-ft-deep recirculating flume (figure 2). The screen was installed on a pipe leading to the suction side of a recirculating pump and located beside a clear plexiglass window to allow viewing and underwater video taping of screen operation. The Sure-Flo SCS8 screen consists of a 20-in diameter outer rotating drum made of a grid mesh and driven by a spray wash system operated at 65 lb/in². The screen has an inside tube about 8-in in diameter with circular openings of various sizes designed to control intake flow to provide a uniform flow distribution through all areas of the screen. The screen was installed with the spray wash jet directed toward the one o'clock position as specified by the manufacturer. Flow velocity in the flume and through the screen was controlled by adjusting control valves on pipes extending from the recirculating pump.

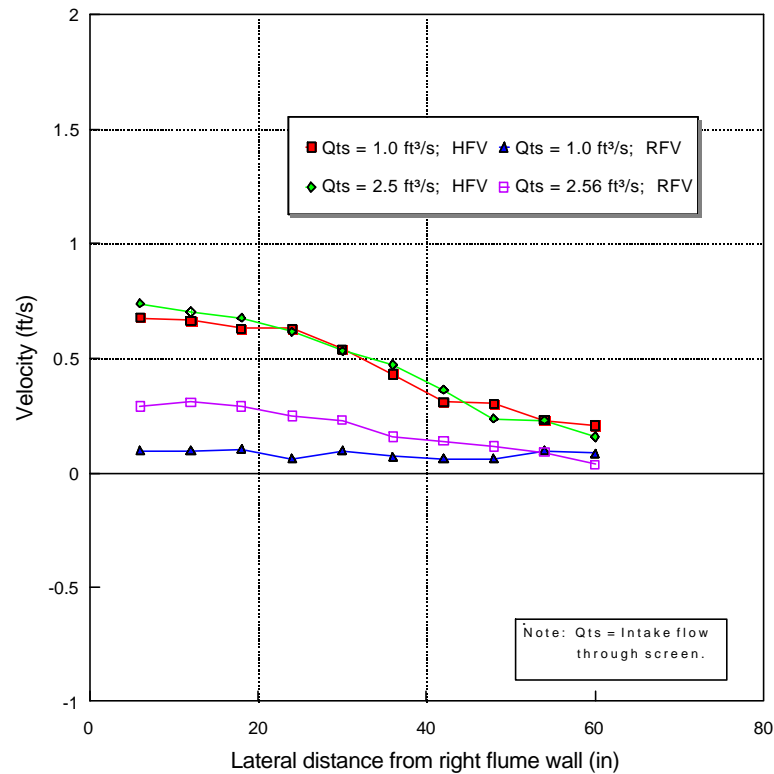
Figure 3. Flume velocity distribution.

In order to simulate an approximate reservoir withdrawal condition (reduced flume velocity), the flume discharge valve was completely closed so that flow was discharging through the test screen only. A true reservoir condition could not be simulated in the flume. However, reasonable quiescent conditions were created by installing a perforated plate upstream from the screen during reservoir tests. Velocities measured across the width of the flume 6 ft upstream from the screen are shown in figure 3.

For the river condition, it should be noted that due to the nature of the test flume configuration, flow rounding a sharp corner about 17 ft upstream from the test screen causes flow velocities on the right side of the flume to be greater than those on the left side on the approach to the screen. Figure 3 also shows the flow distribution across the width of the flume for the HFV condition.

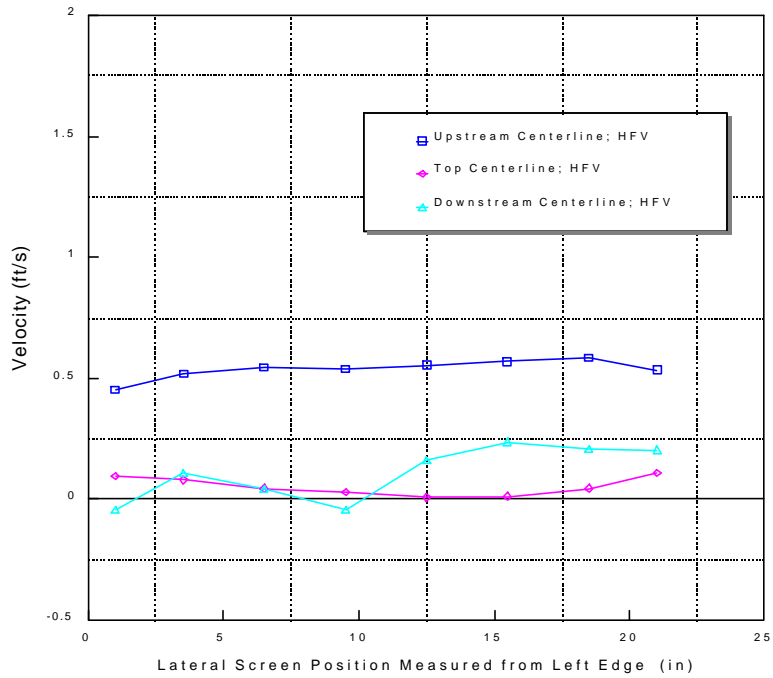
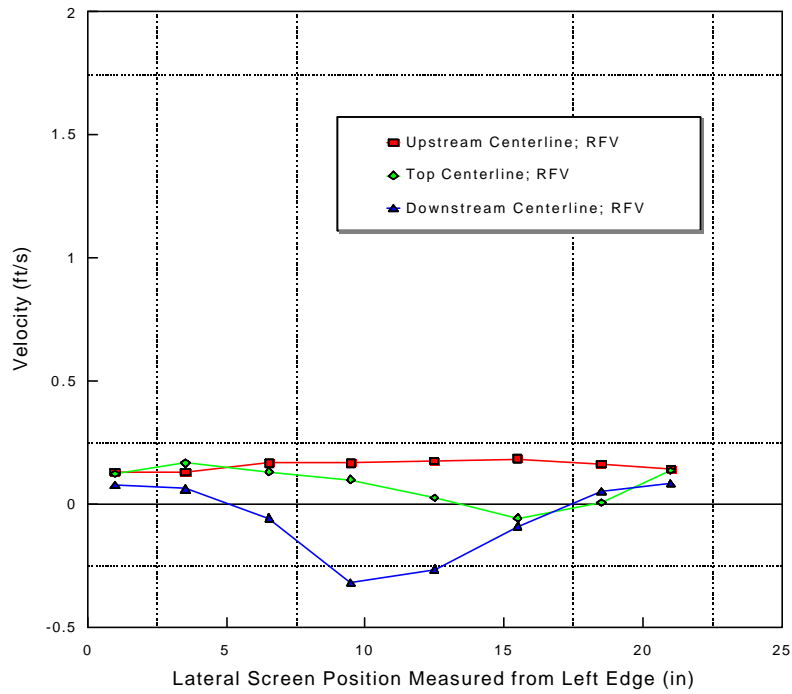
Figure 4. Approach velocities for a screen intake of 449 gpm for condition a) high flume velocity (HFV) and b) reduced flume velocity (RFV). Screen surface is oriented perpendicular to flow.

Figures 4 and 5 show the flow distribution along the length of the screen for each case tested. The following conclusions were determined from the study:

- Tests conducted with the screen oriented perpendicular to the flow show that the upstream approach velocities measured along the length of the screen for the HFV condition are about twice the magnitude of those for the RFV condition. This occurs because the flow in the flume is in the same direction as approach velocities into the screen. As a result, the screen’s ability to meet resource agency velocity criteria is dependent on average streamline flow velocity upstream from the screen.

- The approach velocities measured along the upstream centerline show that the control or baffled openings along the length of the screen performed well to maintain an even flow distribution into the screen, despite an uneven flow distribution across the width of the flume. Fluctuations in the velocities measured along the upstream centerline are all within 20 % of the average upstream centerline velocity for each condition tested.

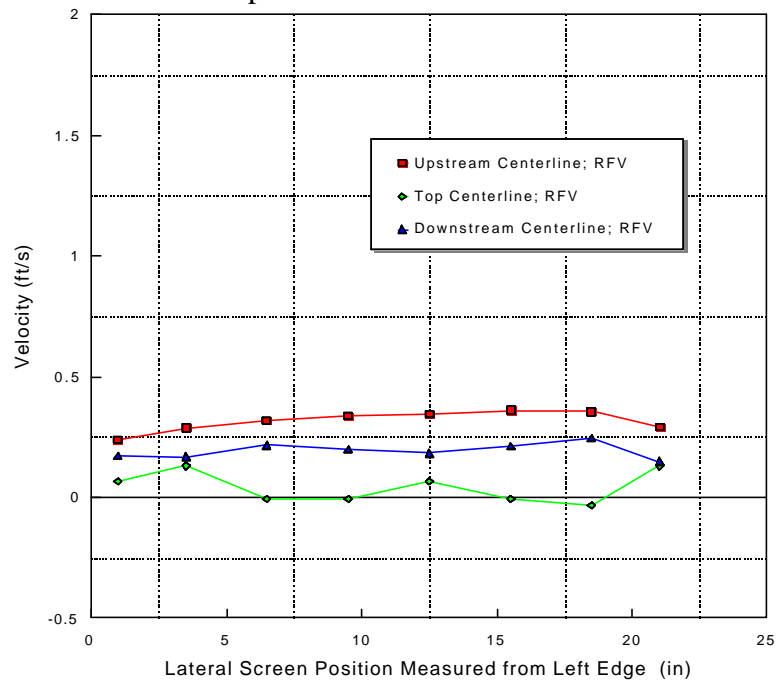
Figure 5. Approach velocities for a screen intake of 1149 gpm for condition a) high flume velocity (HFV) and b) reduced flume velocity (RFV). Screen surface is oriented perpendicular to flow.

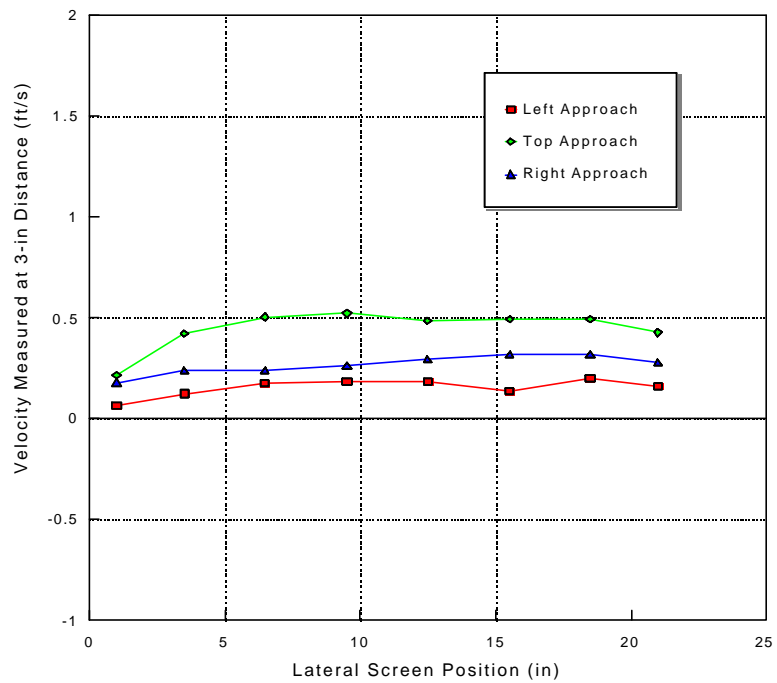
Figure 9. Approach velocities measured 3-in from the screen for a screen intake of 1149 gal/min and reduced sweeping flow. Screen orientation is parallel to flow

Figures 6 through 13 show the flow distribution along the length of the screen for each case tested. The following conclusions were determined from the study:

- a) In general, approach velocities at the upstream end of the screen are lower due to separation that occurs at the leading edge of the screen.
 - b) At the lower discharge, approach velocities measured on the left centerline of the screen are more erratic due to their small magnitude relative to the flow coming from the spray wash jet. In some cases, this causes some flow to come out of the screen.

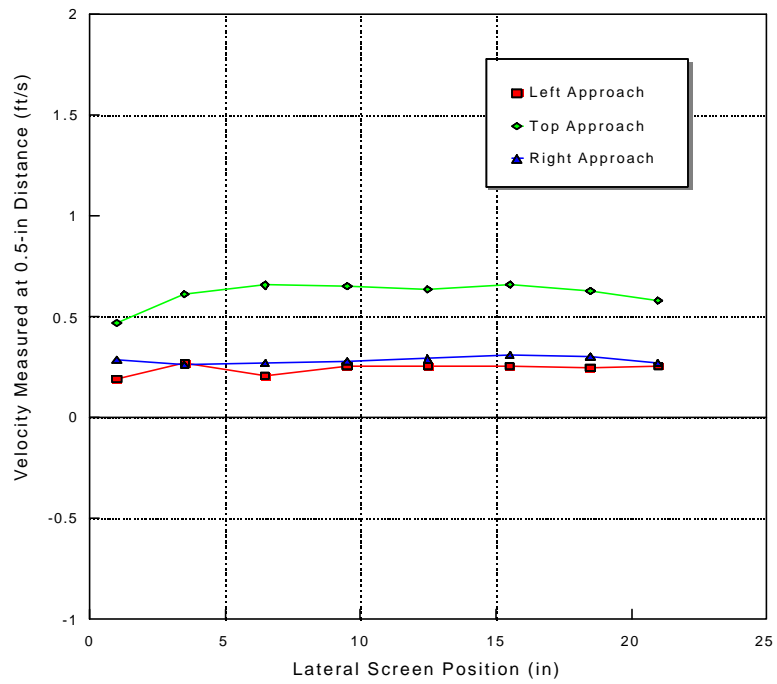
Figure 13. Approach velocities measured 0.5-in from the screen for a screen intake of 1149 gal/min and reduced sweeping flow. Screen orientation is parallel to flow.
